Mobile Pentium® III Processor Specification Update

Release Date: October 1999

Order Number: 245306-001

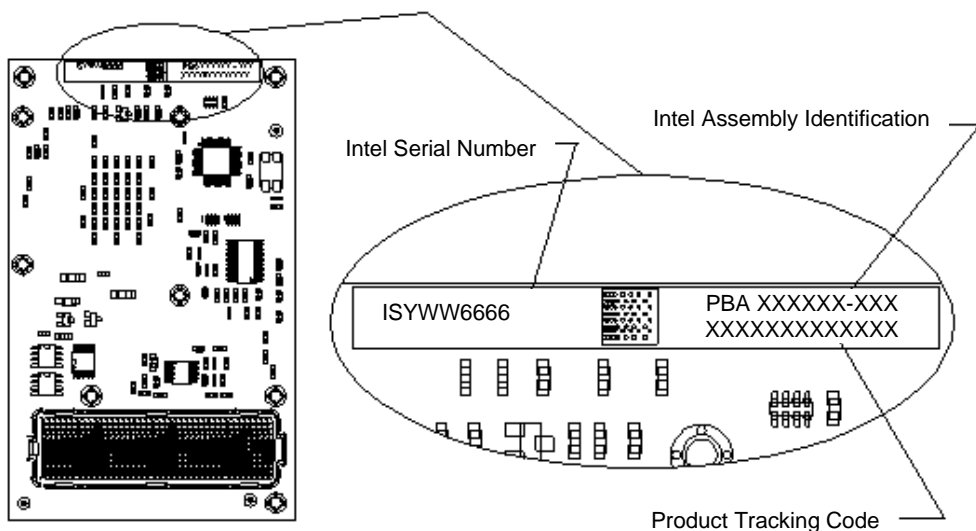
Secondary Side of the Module

- The PTC will consist of 13 characters as identified in the above example and can be broken down as follows:

| EEE | - | Notifiable Design Revision (Start at 001) |
| FF | - | Notifiable Processor Revision (Start at AA) |
